SERVICE BULLETIN

M1492 2019-08-03

M1492: 2017 - 2019 TOURING - MILWAUKEE EIGHT - INNER PRIMARY VENT

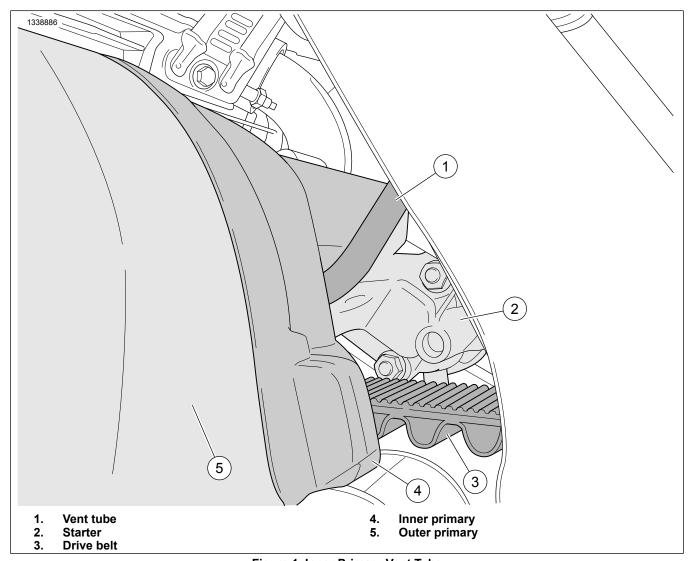
Figure 1. Inner Primary Vent Tube

Harley-Davidson has learned that a small percentage of dealers and customers are finding low transmission oil levels and high primary oil levels during normal maintenance intervals. This could indicate that oil is transferring from the transmission case to the primary housing through the transmission mainshaft.

- Verify that the most current version of the instruction sheet is used. It is available at: www.harley-davidson.com/isheets
- 1. See Figure 1. Check for vent tube (1).
 - If vent tube is present STOP, this service procedure has already been performed.
 - b. If vent tube is not present, go to 2.
- Install Inner Primary Vent Service Kit (Part No. 26500027) per the instructions included in the kit.
- 3. 2017 2018 Models: STOP kit installation is completed.
- 4. 2019 Models: Remove oil deflector.
 - Remove transmission inner side cover. See the service manual.
 - Remove mainshaft transmission oil deflector (Part No. 36300026).
 - c. Install transmission side covers. See service manual.
