# SERVICE BULLETIN

M1289

October 11, 2010

## 2006-2011 Touring Models Handlebar Clamp Screw Running Change/CD Skip

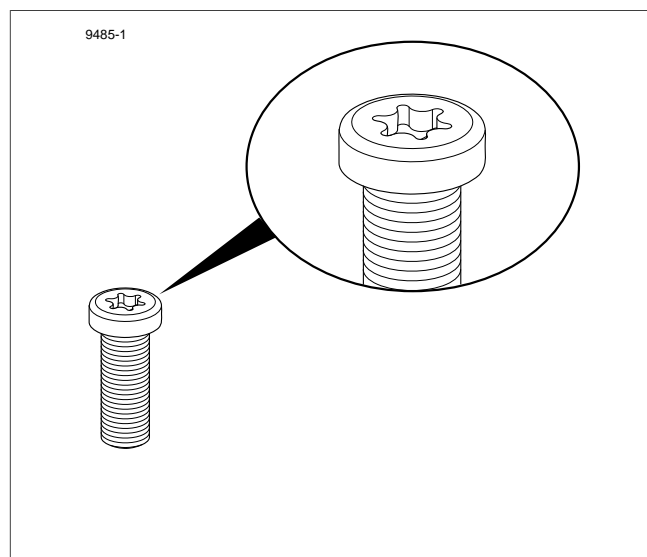
The purpose of this bulletin is to inform dealers of a running change to the fastener used to secure the handlebar clamp to the risers. For all 2011 Touring models built approximately on or after October 7, 2010, a new fastener, (Part No. 12600003), is being implemented in all four locations on the handlebar clamp. On all 2011 Electra Glide Touring models equipped with the Advanced Audio System, the new fastener will provide additional clearance between the two forward handlebar clamp fasteners and the radio chassis. Lack of clearance at this location has been determined to be a major contributor to CD skip and other audio system concerns.

**Figure 1. Updated Handlebar Torx Head Fastener with Shorter Head**

On 2006-2011 Electra Glide Touring models equipped with the Advanced Audio System, if a customer has concerns about CD skip, inspect vehicle for contact between the handlebar clamp screw head and the radio chassis. If contact exists, remove the radio, replace the two forward handlebar clamp fasteners (there will be no kit, the dealer will be required to order two Part No. 12600003 screws) and reassemble following service manual procedures.
