TT418A: DTCs P2135 and P2101 Theory and Diagnostics

January 7, 2011

APPLIES TO	SYMPTOMS
2008-Later Touring, Police and Trike Models	<ul style="list-style-type: none"> • Driveability or Performance Concerns • Abnormal or Erratic Mechanical Operation • Intermittent or Erratic Electrical Operation

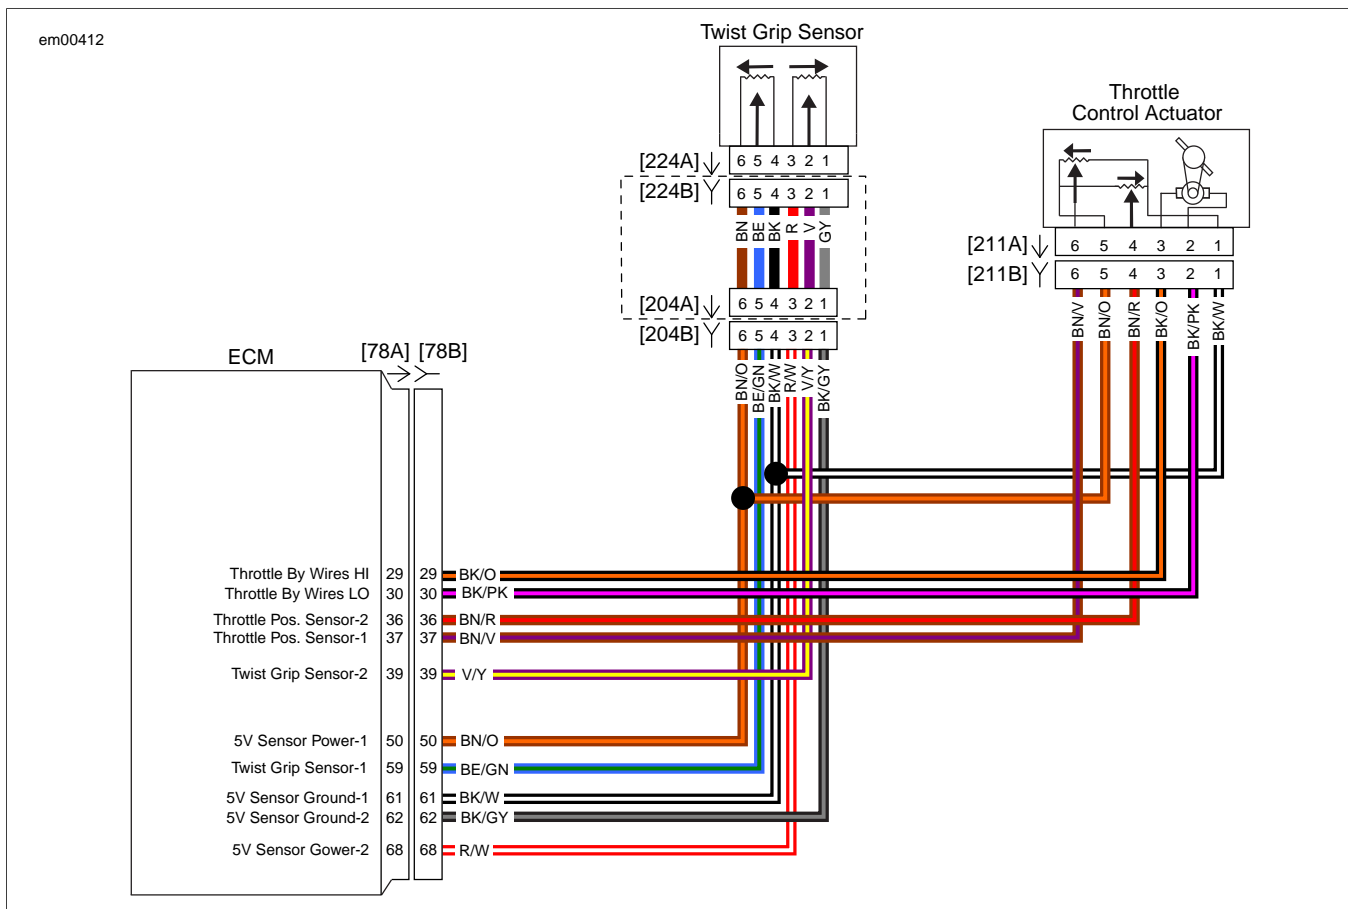
Figure 1. TCA Circuit Schematic

The TPS 1 and 2 sensors should never add to more than 5.13 Volts Direct Current (VDC) or less than 4.87 VDC. A sum of voltages out of this range should register a current P2135 code.

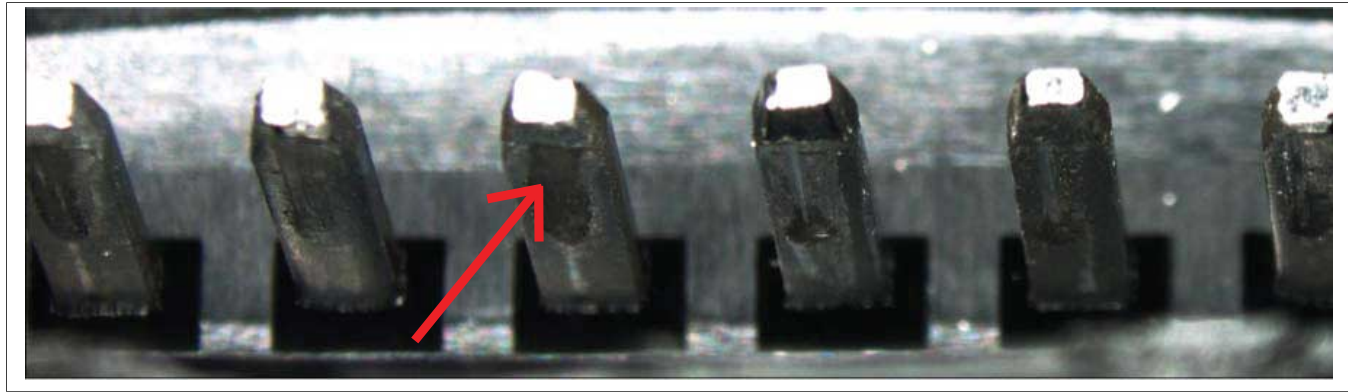
It is believed that fretting corrosion is a major contributor to this code. A poor connection at the TCA can affect the sensor voltages reported to the ECM and set this DTC. As you can see from the General Information section, the sensor voltage only needs to be altered by 0.13 VDC to possibly set the code.

The most common vehicles to have these symptoms are those with more than 8000 miles (12,875 kilometers), or 103 cubic inch (1680 cubic centimeters) and larger engines. Vibration is believed to contribute to the fretting condition.

Figure 2. Example of Terminal Fretting

1. While monitoring the TPS1 and TPS2 voltages on Digital Technician II (DT II), wiggle the TCA [211] and the ECM [78] connectors.
2. If the voltage changes while wiggling the ECM connector, replace the affected ECM terminals (Part No. 72605-08). These wires are: TPS1, pin 37 brown/violet (BN/V) wire of the ECM, and TPS2, pin 36 brown/red (BN/R) wire of the ECM.
3. If no voltage change is noted while moving the ECM connector, the connection issue could be in the TCA. Replace all socket terminals with **new** terminals (Part No. 72663-11, used in current production) at the TCA connector [211B] .

- Before connecting the TCA connector, clean the male TCA pin terminals with a swab and alcohol, and assemble with dielectric grease (Part No. 99861-02, Nyogel 760G).
