SERVICE BULLETIN

M1657: RECALL 0186 - 2024 Center-Cooled Regulator Wiring

M1657

2024-09-18

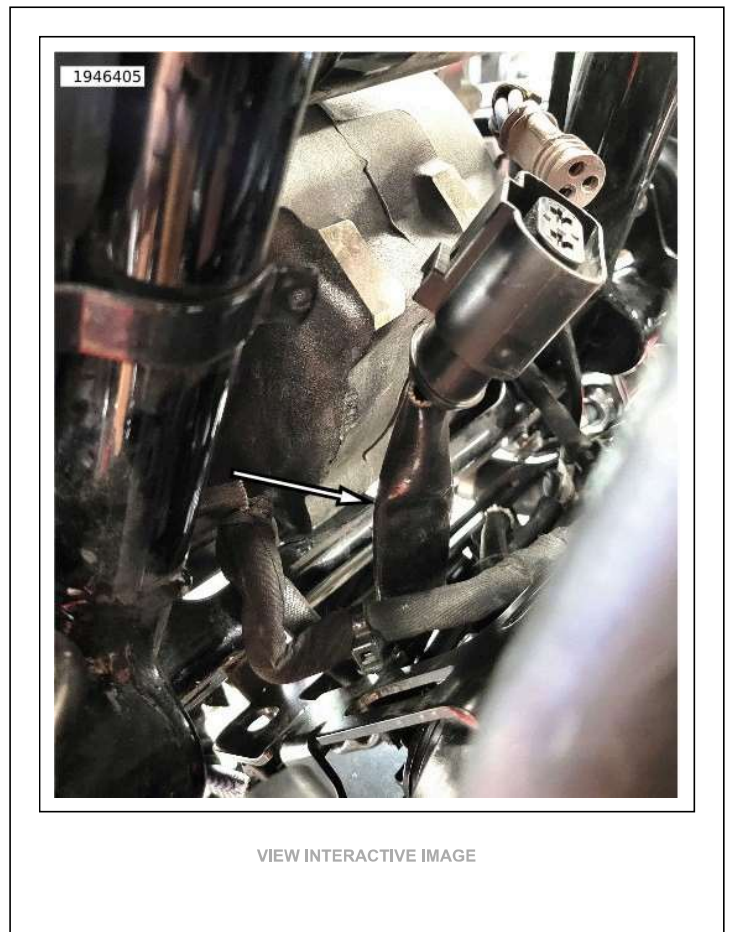
Figure 1. Inspection Area

9. [See Figure 1](#). Lean cooling system bracket forward toward front fender.

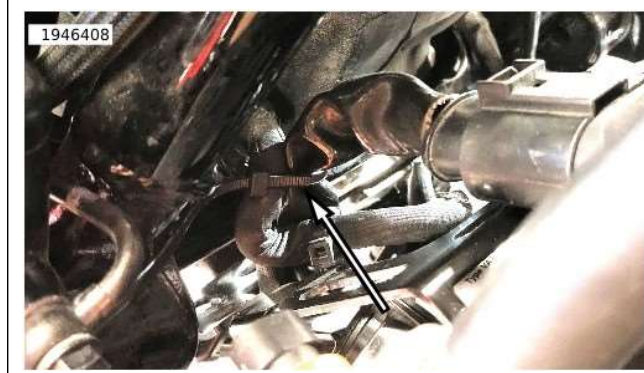
2. See [See Figure 3.](#) and [See Figure 4.](#) Secure voltage regulator harness into position with cable strap.

Figure 3. Tight Cable Strap

Figure 4. Loose Cable Strap

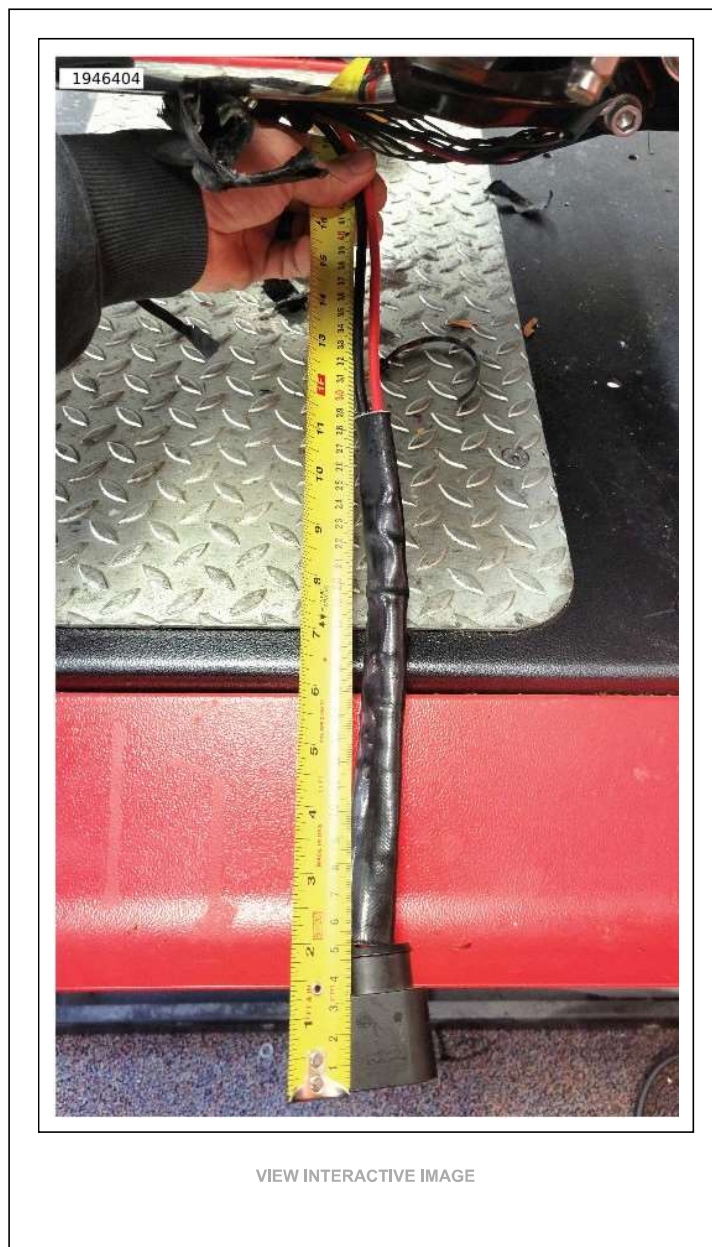
Figure 6. Separated Wire Harness

4. Separate voltage regulator RED and BLACK wires from main harness loom.
 - a. [See Figure 6](#). Exposing approximately 18" (457mm).

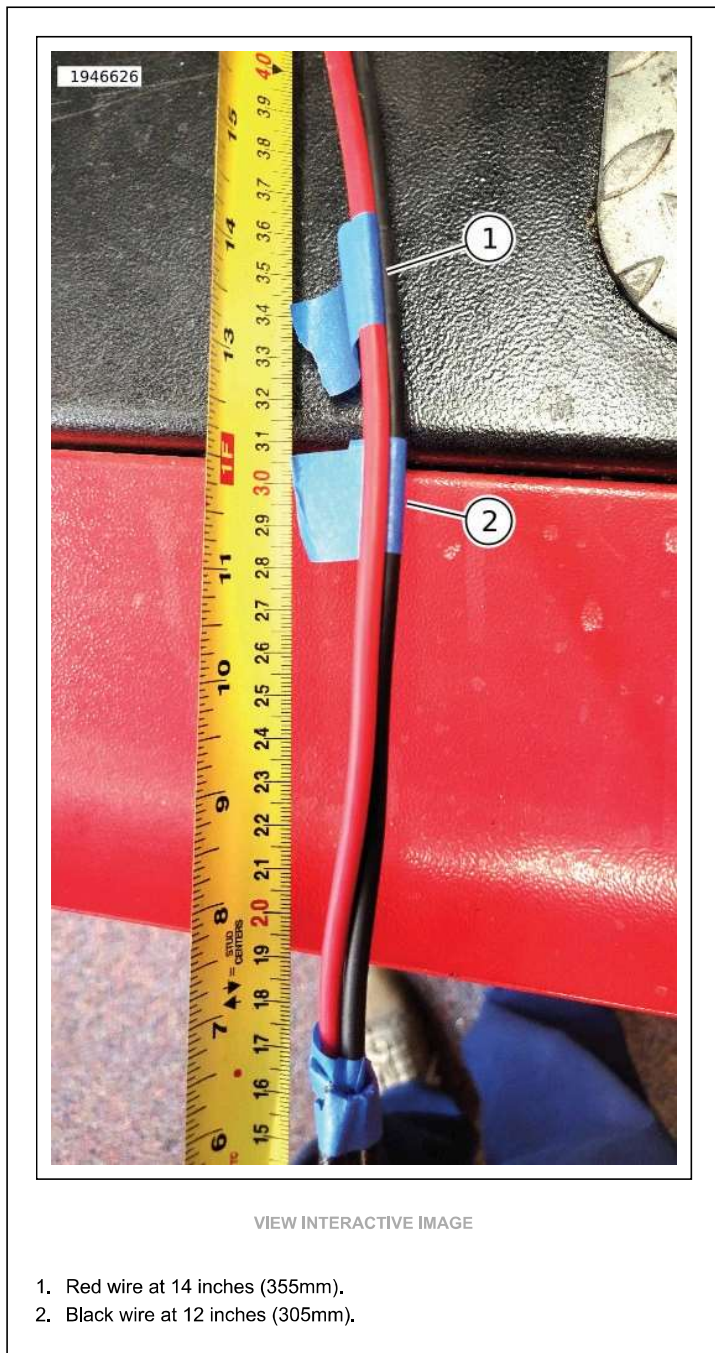
Figure 7. Measured Locations

5. [See Figure 7](#). Measuring from the front of the voltage regulator connector [77] cut the RED wire at 14 inches (355mm).

6. Measuring from the front of the voltage regulator connector [77] cut the BLACK wire at 12 inches (305mm).

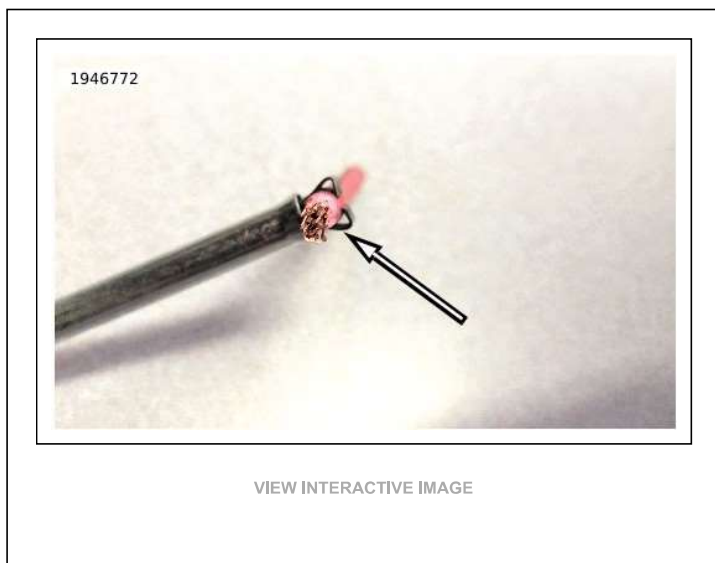
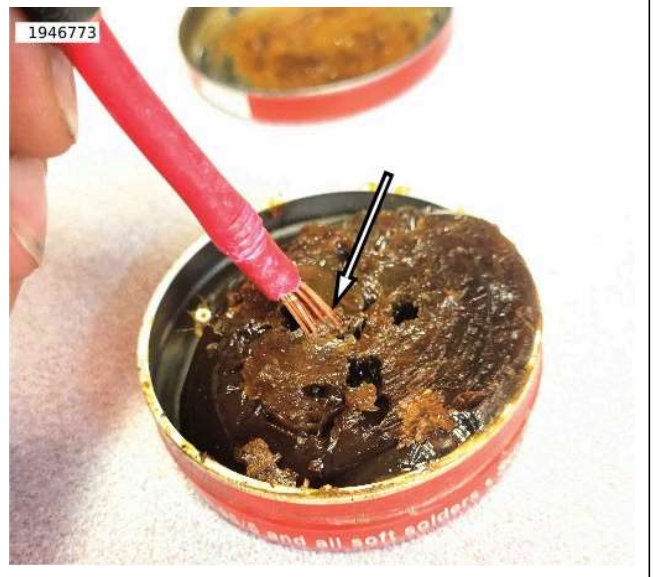
9. See [See Figure 13.](#) - [See Figure 18.](#) Solder in place [Direct Current \(DC\)](#) lead from Recall kit (Part No. 69203711).

Figure 13. Exposed Wire

Figure 14. Mechanically Grip Wire

Figure 15. Dip Wire Into Flux

Figure 16. Position Wires

Figure 17. Intertwine Wires

Figure 18. Wrap Joint with Thin Gage Wire

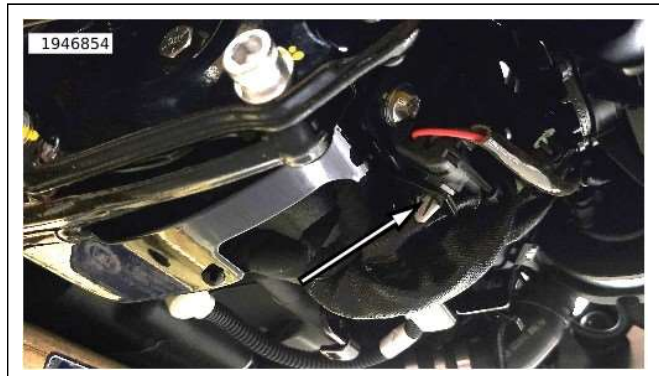
Figure 24. Anchored Cable Strap

11. Position voltage regulator wires with main harness loom and wrap with harness wrap from Recall kit (Part No. 69203711).
12. Install anchored cable strap on harness.
13. Route harness to proper position.
14. Connect voltage regulator connector [77].
15. [See Figure 24](#). Seat anchored cable strap into frame tab.

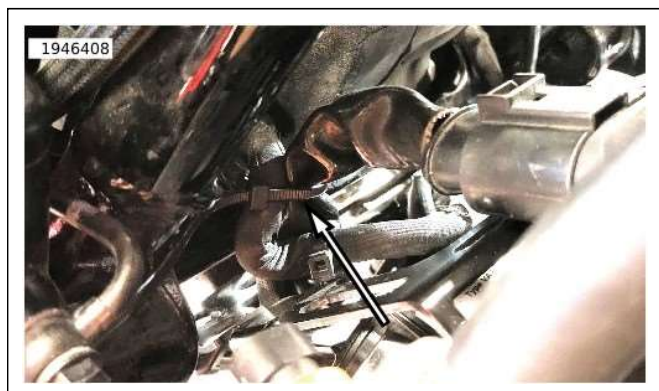
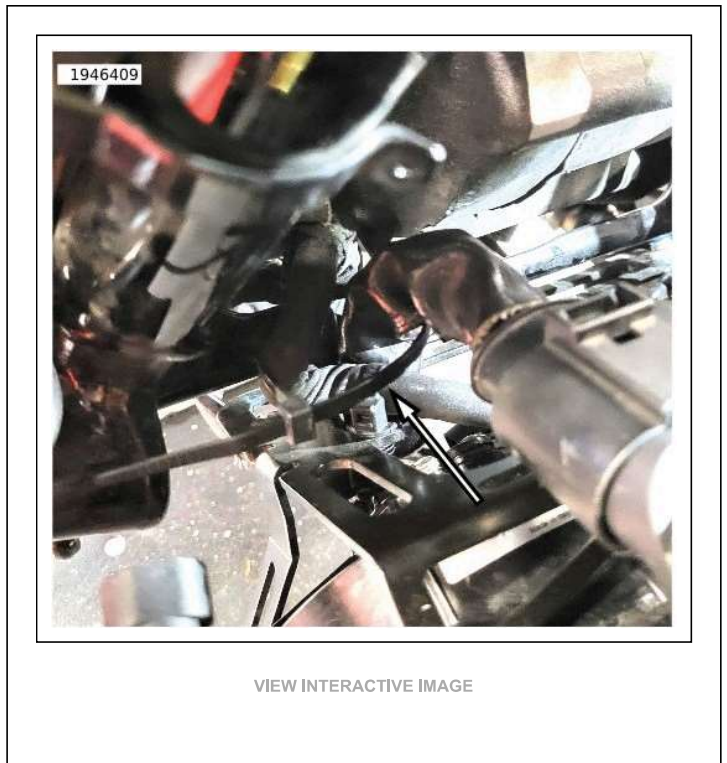
16. See [See Figure 25](#), and [See Figure 25](#). Secure voltage regulator harness into position with cable strap around regulator harness and coolant pump harness in location shown.

Figure 25. Tight Cable Strap

Figure 26. Loose Cable Strap
